THREE-YEAR AHERA REINSPECTION

MOUNT ZION CHRISTIAN SCHOOL

132 TITUS AVENUE
MANCHESTER, NEW HAMPSHIRE

January 2010

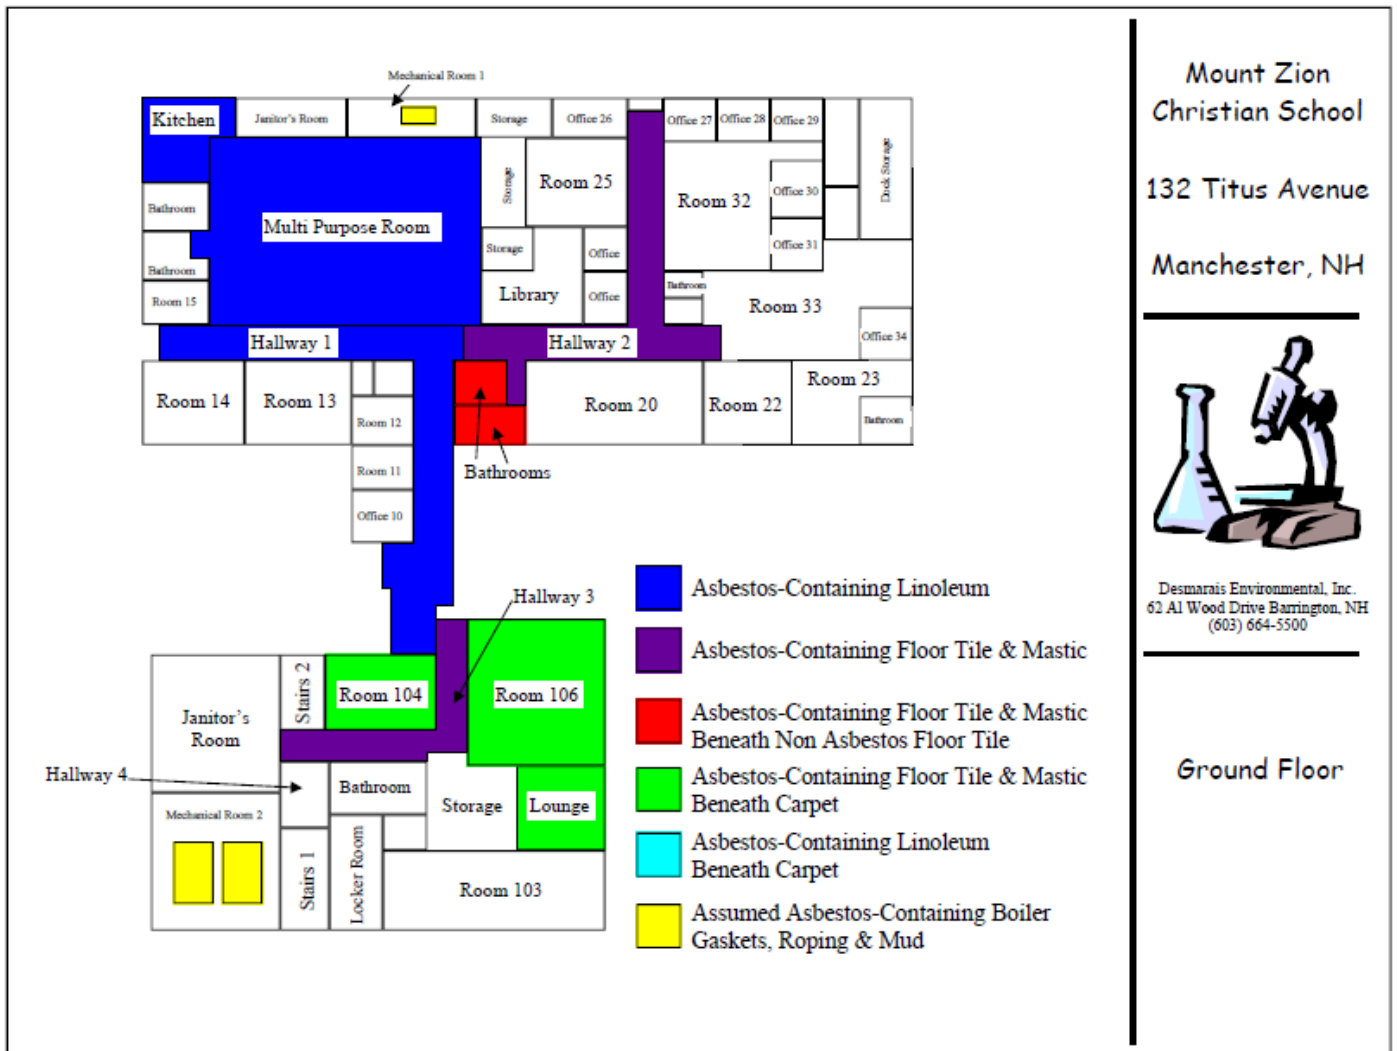
Map 1 of 3

Location	Asbestos-containing Material	Condition	AHERA Code	Quantity (ft ²)
Ground Floor – Kitchen	Linoleum	Good	5	450
Ground Floor – Mechanical Room 1	Boiler Gaskets, Roping, etc.	Enclosed	7	-
Ground Floor – Multi Purpose Room	Linoleum	Minor Damage (Cracking)	5	2,650
Ground Floor – Hallway 1	Linoleum	Minor Damage (Cracking)	5	1,625
Ground Floor – Hallway 2	Floor Tile & Mastic	Minor Damage (Cracking)	5	1,025
Ground Floor – Bathrooms Off Hallway 2	Floor Tile & Mastic	Enclosed with Floor Tile	5	600
Ground Floor – Hallway 3	Floor Tile & Mastic	Good	5	485
Ground Floor – Room 106	Floor Tile & Mastic	Enclosed with Carpet	5	971
Ground Floor – Room 104	Floor Tile & Mastic	Enclosed with Carpet	5	340
Ground Floor – Lounge	Floor Tile & Mastic	Enclosed with Carpet	5	330
Ground Floor – Mechanical Room 2	Boiler Gaskets, Roping, etc.	Enclosed	7	-
2 nd Floor – Room 204	Linoleum	Enclosed with Carpet	5	630
2 nd Floor – Science Room	Floor Tile & Mastic	Enclosed with Floor Tile	5	1,000

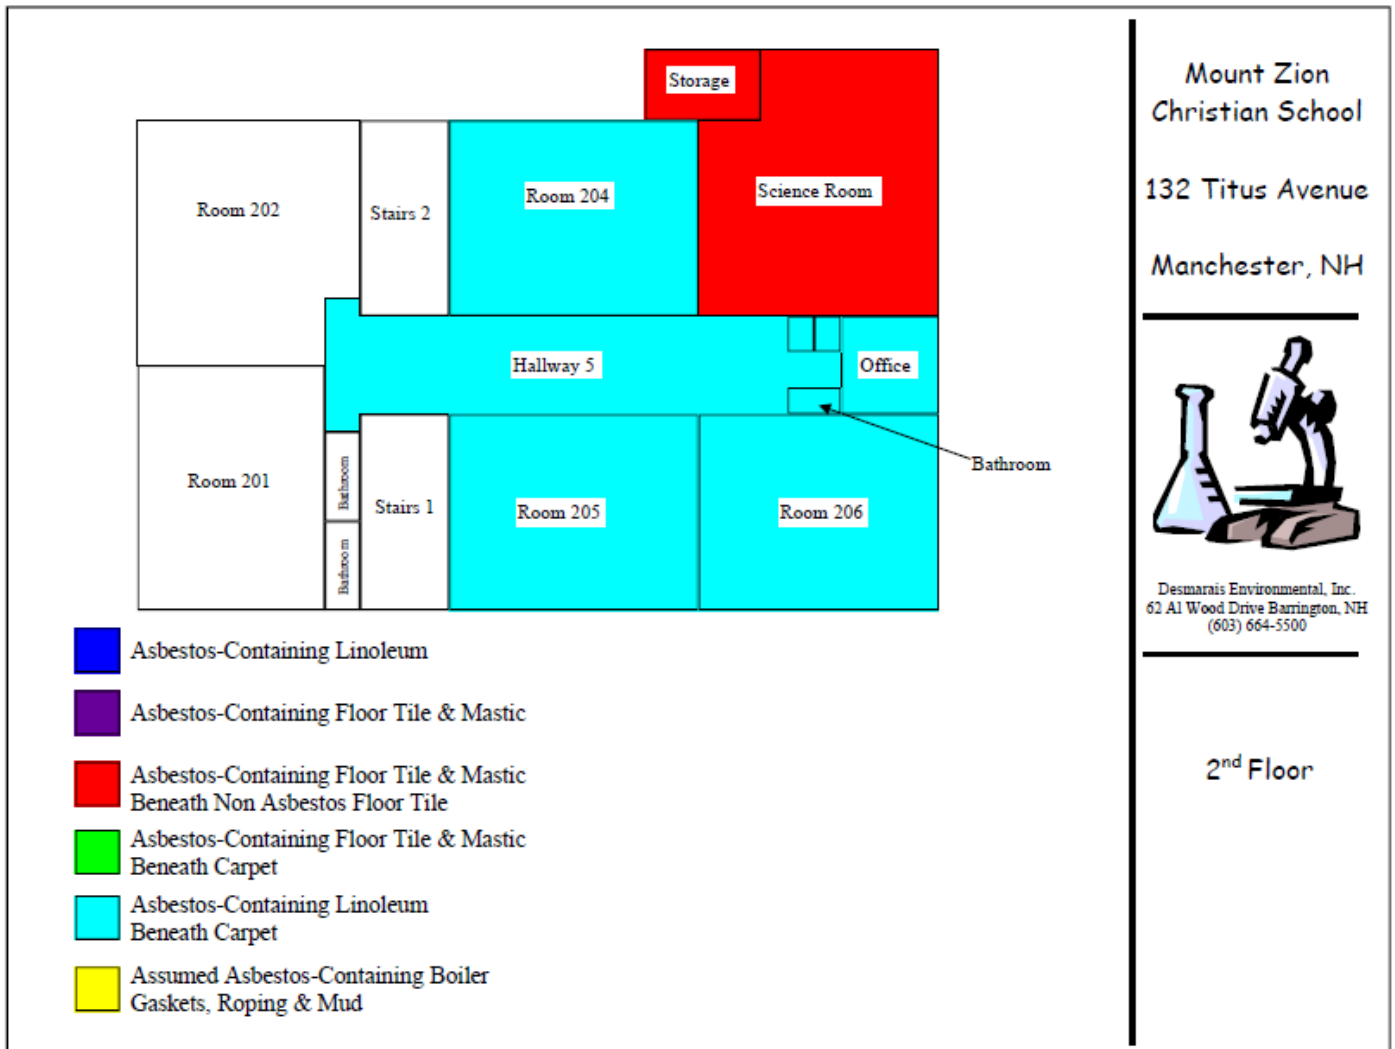
Map 2 of 3

2 nd Floor – Science Room Storage	Floor Tile & Mastic	Enclosed with Carpet	5	125
2 nd Floor – Room 205	Linoleum	Enclosed with Carpet	5	675
2 nd Floor – Room 206	Linoleum	Enclosed with Carpet	5	675
2 nd Floor – Office with Bathroom	Linoleum	Enclosed with Carpet	5	300
2 nd Floor – Hallway 5	Linoleum	Enclosed with Carpet	5	715

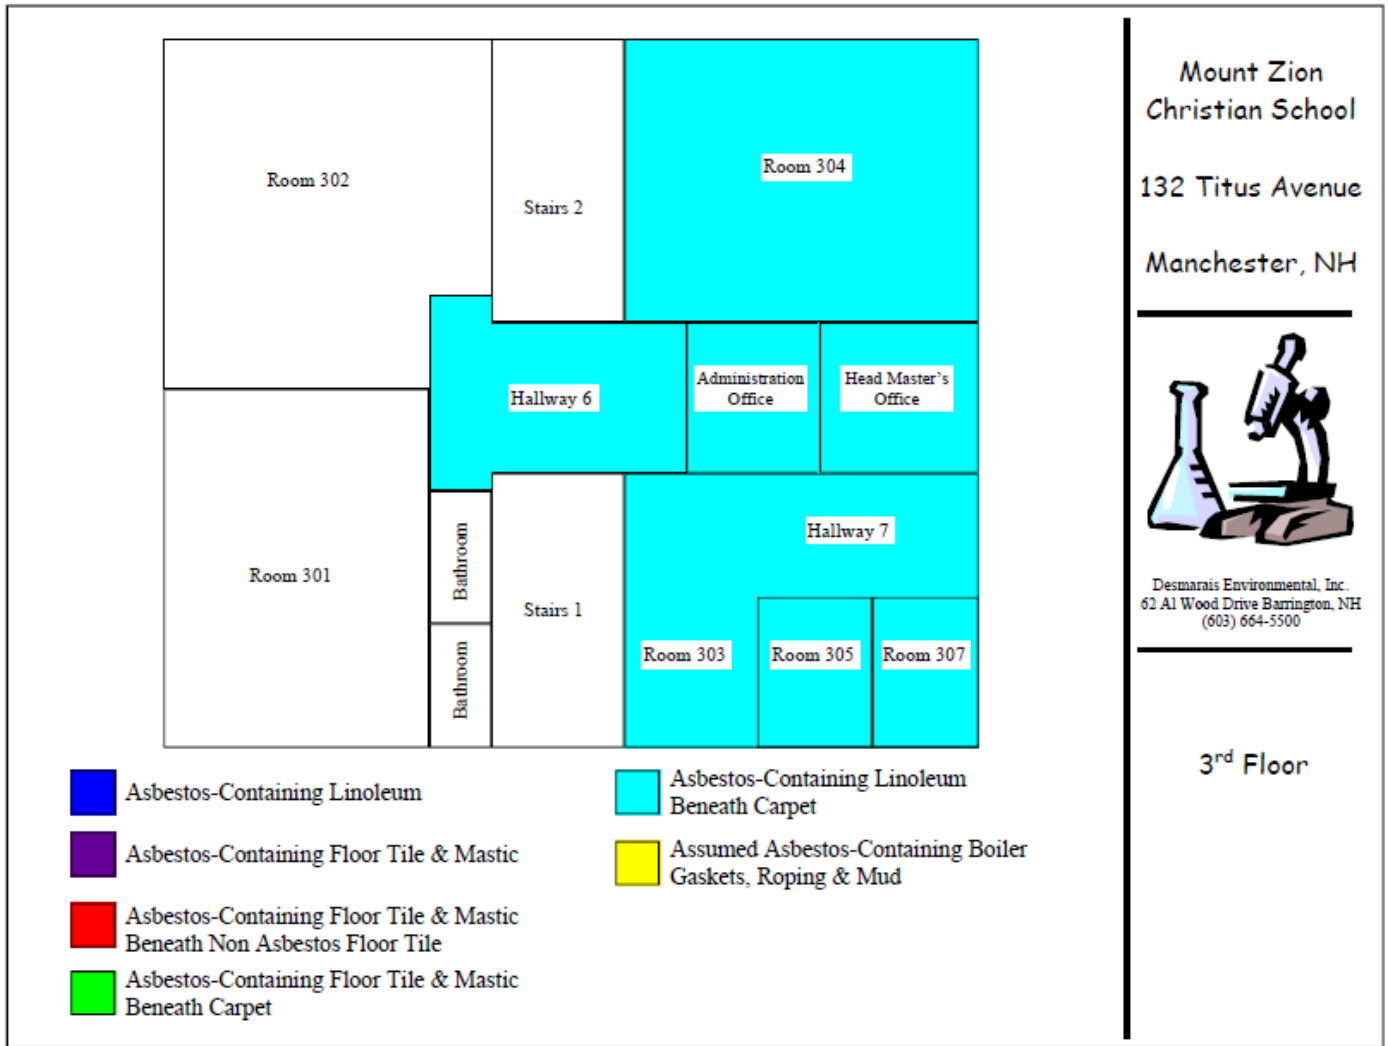
3rd Floor

Location	Asbestos-containing Material	Condition	AHERA Code	Quantity (ft ²)
3 rd Floor – Room 304	Linoleum	Enclosed with Carpet	5	650
3 rd Floor – Administration Office	Linoleum	Enclosed with Carpet	5	140
3 rd Floor – Head Master’s Office	Linoleum	Enclosed with Carpet	5	175
3 rd Floor – Room 303	Linoleum	Enclosed with Carpet	5	200
3 rd Floor – Room 305	Linoleum	Enclosed with Carpet	5	115
3 rd Floor – Room 307	Linoleum	Enclosed with Carpet	5	100
3 rd Floor – Hallway 6	Linoleum	Enclosed with Carpet	5	260
3 rd Floor – Hallway 7	Linoleum	Enclosed with Carpet	5	215
